Methods and Results

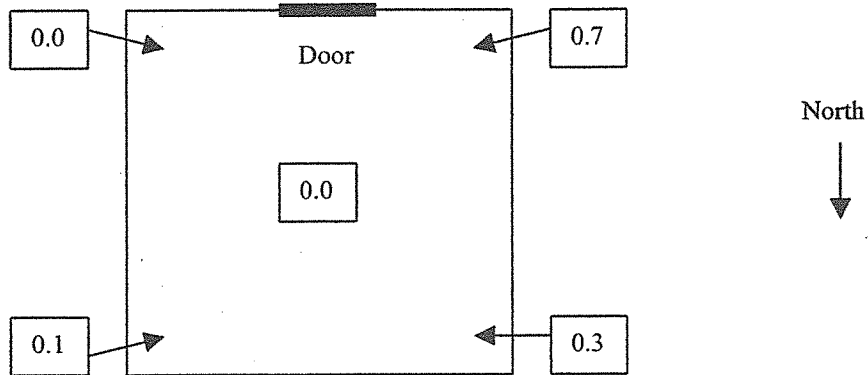
Indoor

All samples were taken with a Narda 06 E-9 monitor which was calibrated by the OSHA Cincinnati Technical Center on May 5, 2004. The diagrams below illustrate the levels that were detected during the survey. Those results in red indicate an overexposure to FCC standards.

These samples were taken inside the lookout on the top level. No overexposures were detected inside the lookout.
